CITY OF DUVALL

Big Rock Road 2.2 MG Reservoir Improvements

REQUEST FOR QUALIFICATIONS

RE: Reservoir Evaluations and Recommendations

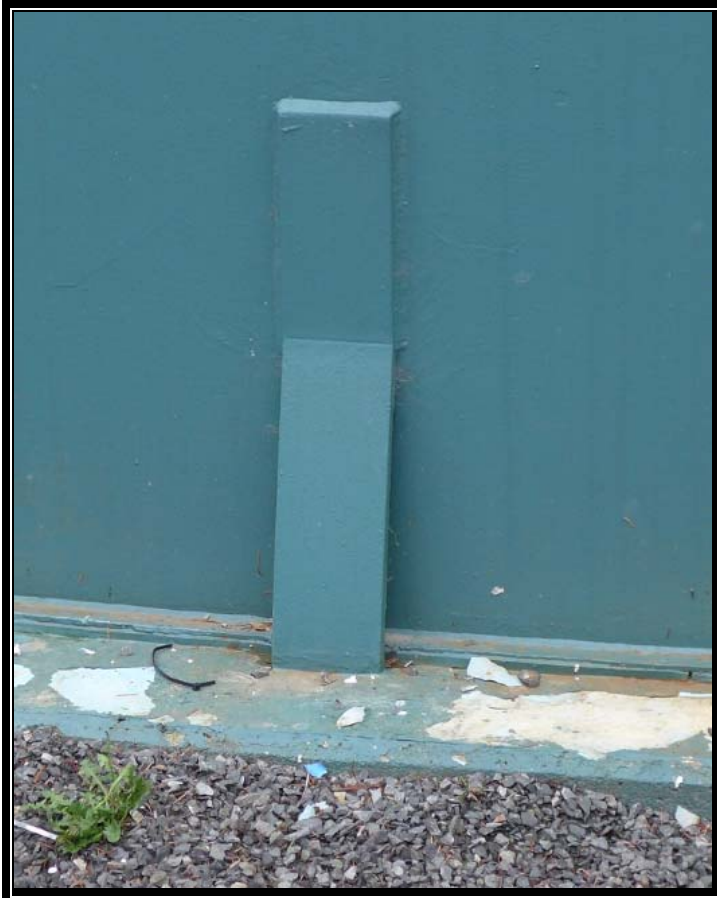
Photograph 3: 0.5MG Reservoir Existing Anchorage

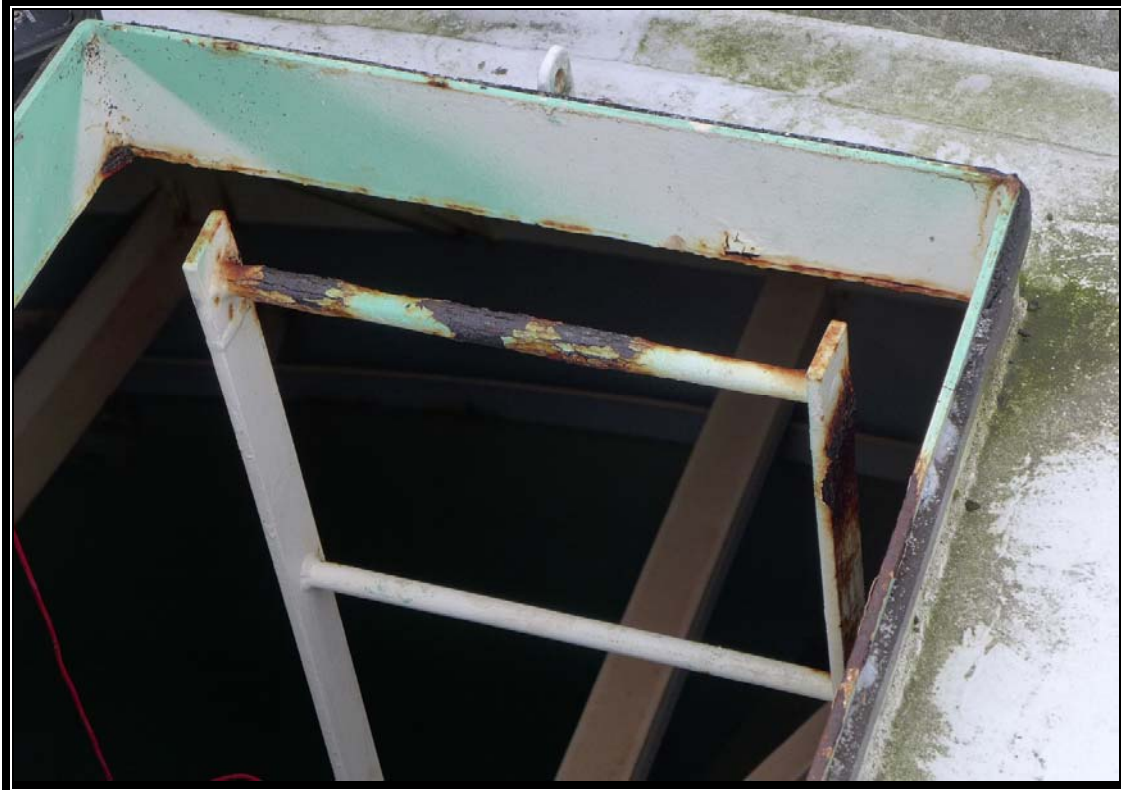
Photograph 5: 0.5MG Reservoir Hatch and Interior Ladder with Minor Corrosion

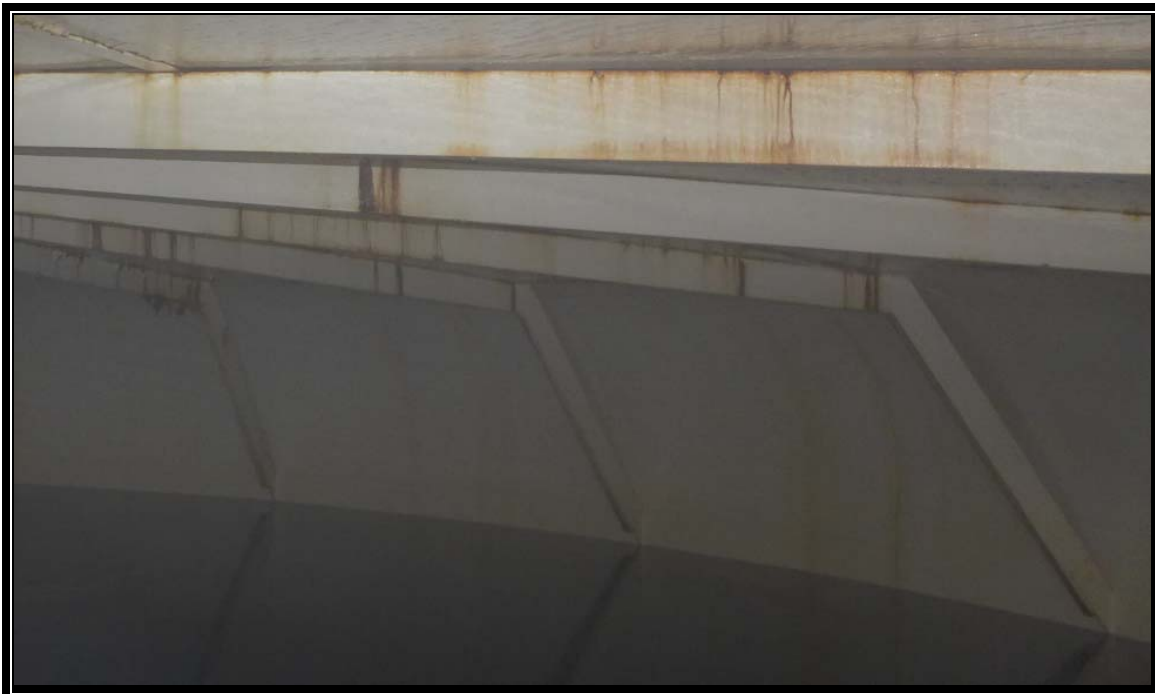
Photograph 10: 0.5MG Reservoir Corrosion of Roof Framing Members

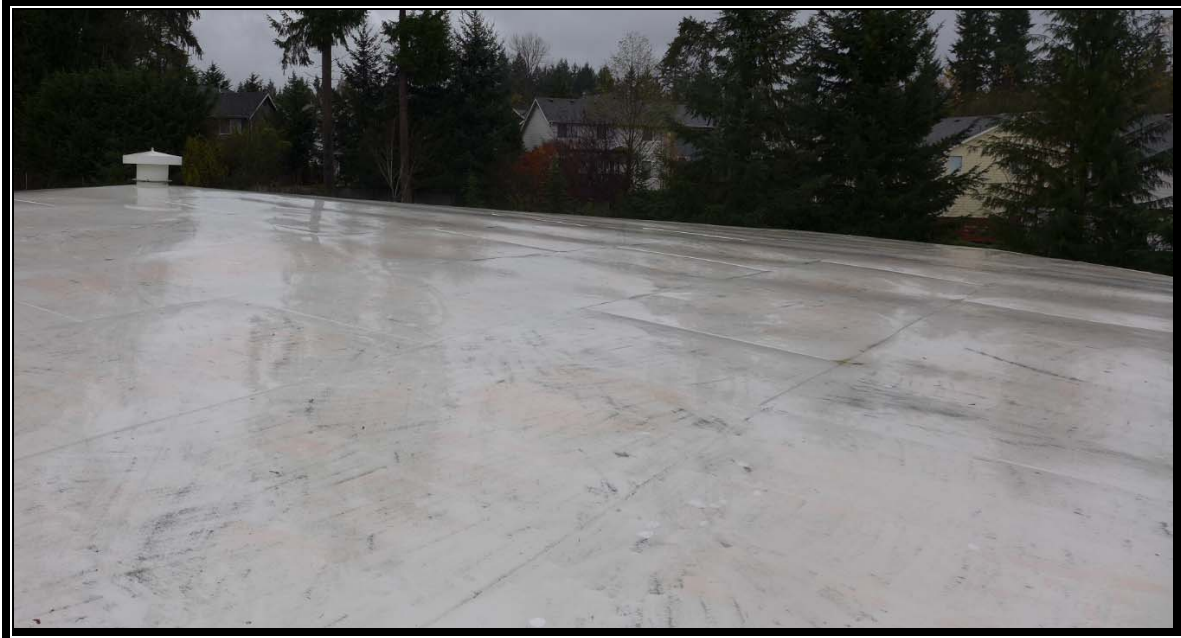
Photograph 13: 2.2MG Reservoir Buckled Roof Plates

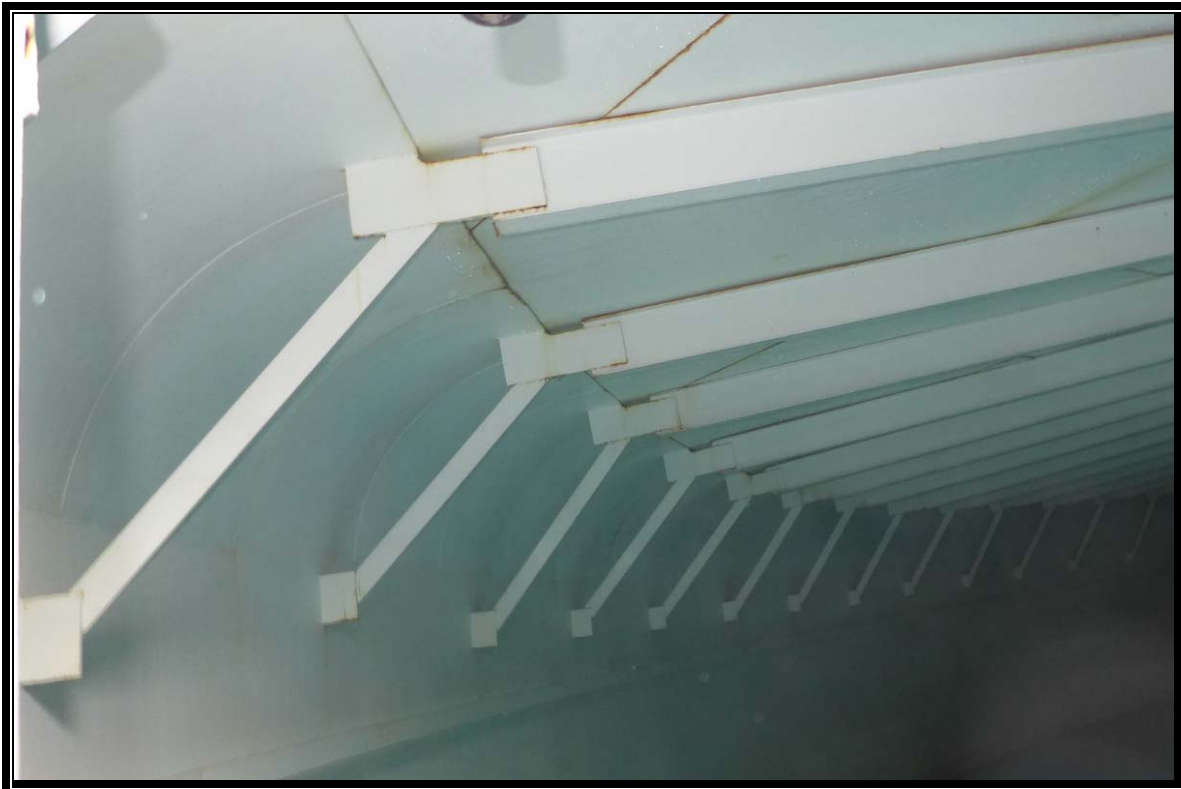
Photograph 16: 2.2MG Reservoir Roof Plates with Minor Corrosion

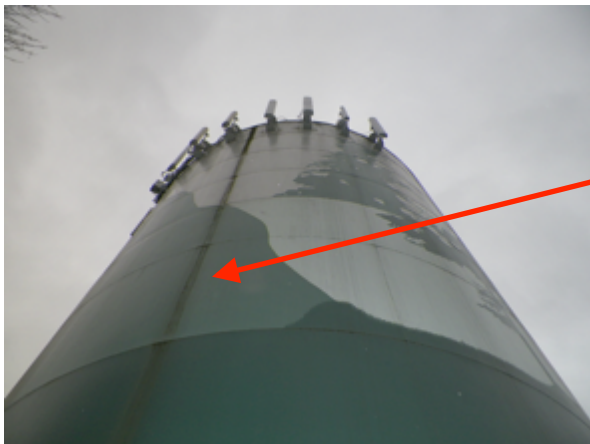
0.5 MG - Exterior sidewall debris

The northern side of the reservoir roof has a low area that is supporting rain runoff concentrating at one location along the side of the reservoir. This allows for the accumulation of moss and other organic material growth along the side that will cause coating damage and premature failure.

Area of organic film build-up

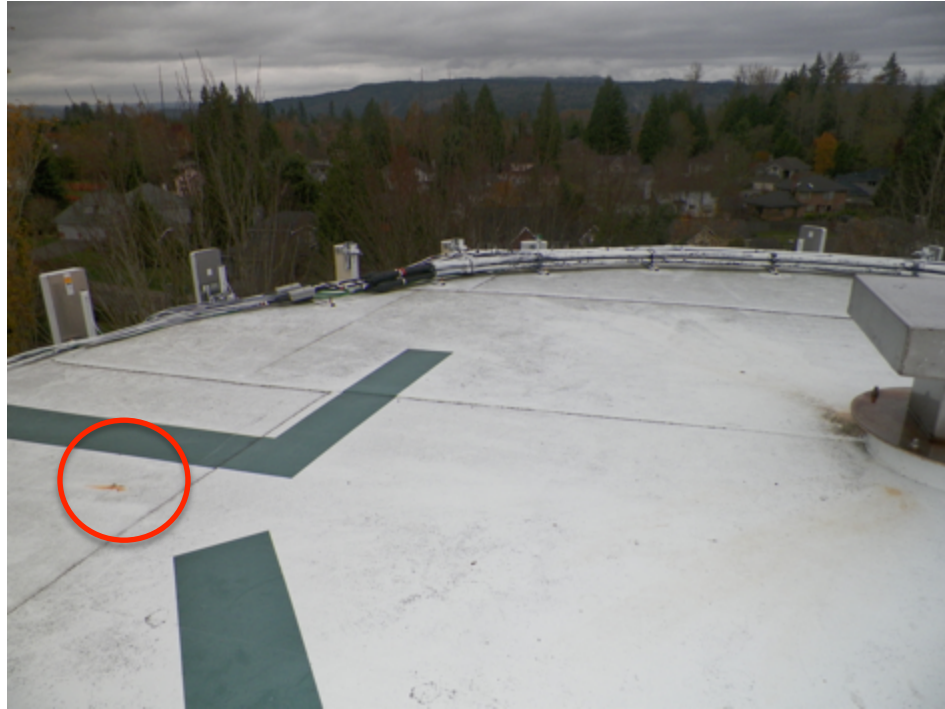
The coating on the 0.5 MG reservoir roof is dirty and there are approximately six quarter-sized defects where the coating has failed to bare metal. There was no steel pitting at these sites and so long as minor coating repairs are completed, further steel deterioration will not occur.

0.5 MG - Dirt on roof and small coating defect

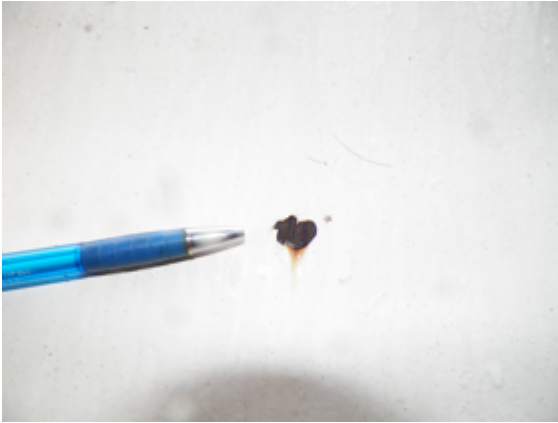
The 2.2 MG reservoir has numerous (perhaps up to 100) rock chips on the lower northeast side of the structure. This location is adjacent to a tiered grassy area where mowers likely throw small rocks against the side of the reservoir. Steel is exposed at these locations, but there was no noted pitting.

2.2 MG - Typical dime sized coating defect

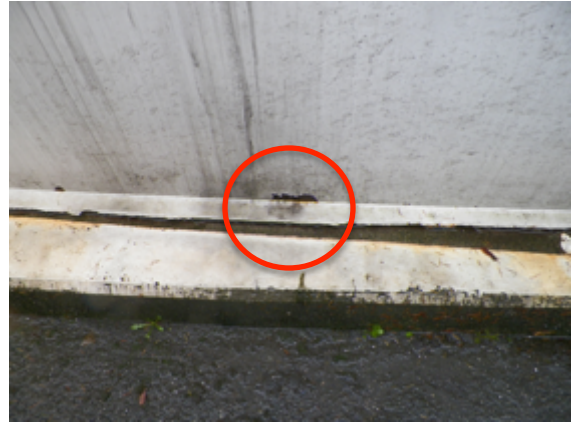
2.2 MG – Coating failure at chine

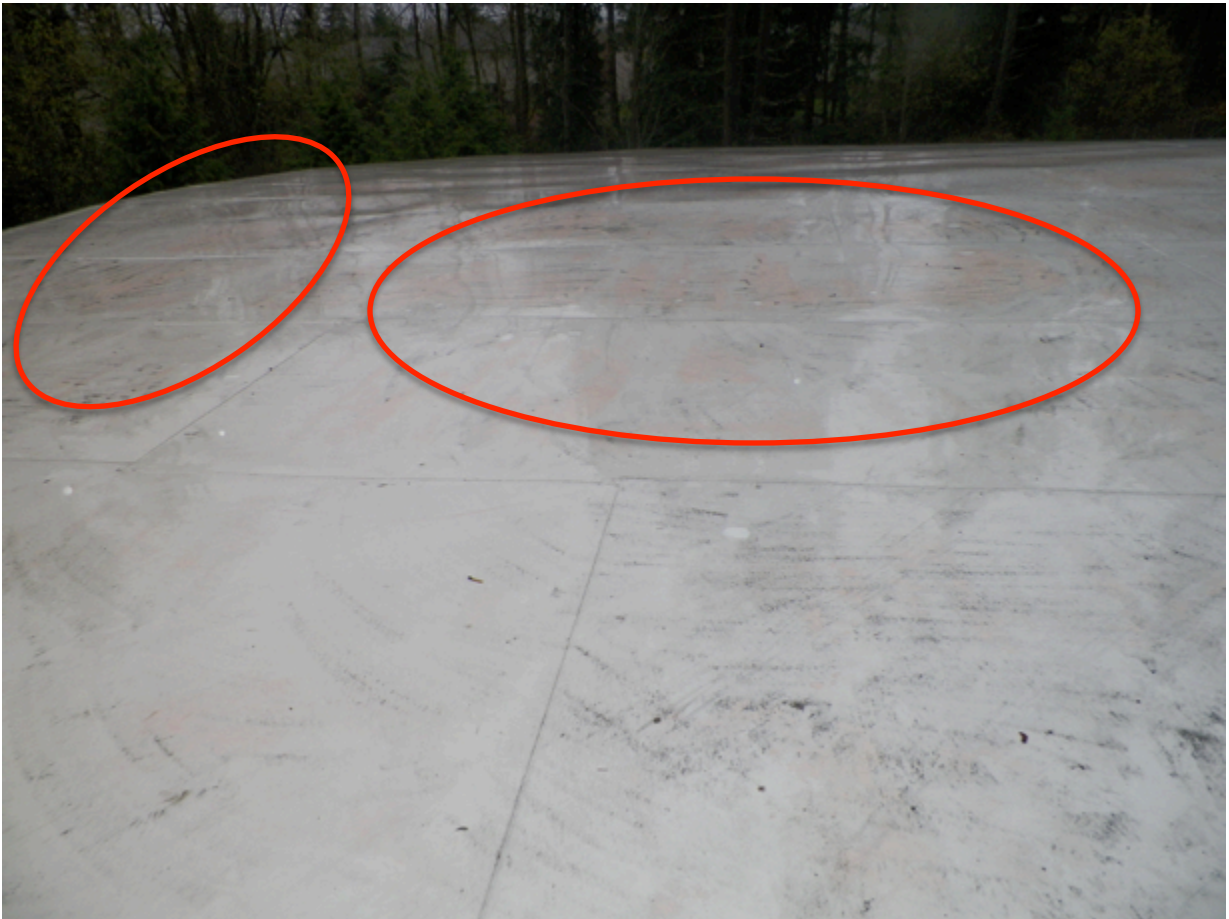
NCE identified several coating deficiencies in the existing reservoir system during their evaluation. The most significant is the exterior topcoat of the reservoir roof, which is in poor condition with approximately 35 to 40 percent of the topcoat missing and the remainder loosely adhered to the intermediate coat. The exterior shell has numerous coating flaws generally located on the north to northeast side. Other deficiencies associated with corrosion and observations by NCE include:

The roof of the 2.2 MG reservoir is experience approximately 35 – 40% topcoat failure. The remainder of the topcoat is loosely adhered to the intermediate coat at all tested locations. There are approximately twelve instances of failure to steel on the roof with no associated pitting.

2.2 MG – Topcoat failure, comprising approximately 35 – 40% of roof

1. Repair the areas of damaged coating, including the interior roof hatch surfaces, painter's rail, support columns and any other damaged locations;
2. Remove all non-adherent existing topcoat material, scarify the intermediate coating and apply a tie-coat and polyurethane topcoat.
3. Seal the interior non-welded joints, by welding or applying a caulking compound, to prevent further corrosion; and
4. Install a galvanic anode cathodic protection system for the interior of the reservoir to provide corrosion control for all interior submerged systems.

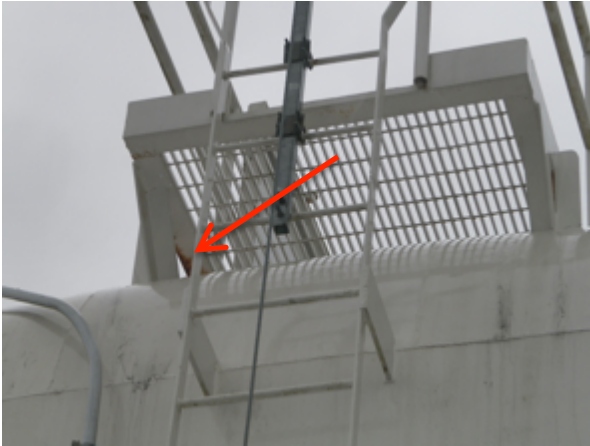
2.2 MG - Missed coating on bottom of exterior landing

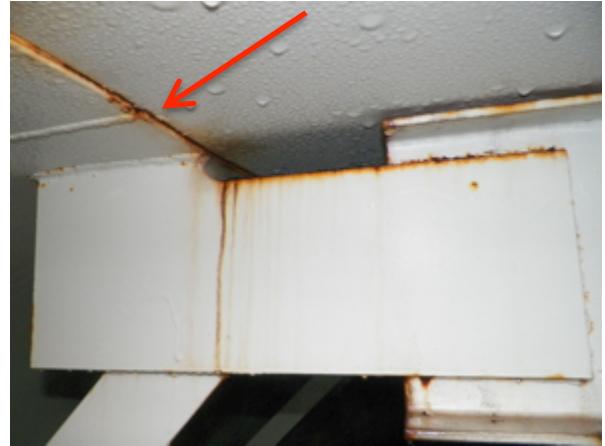
Both reservoirs were constructed without seal welding the interior roof lap joints or the internal beam supports in close contact with the roof. This has resulted in crevice corrosion at multiple locations within these overlap areas. The corrosion has resulted in rust staining, but it is unlikely that significant damage has occurred. The edges of the painter's rails and ladder supports have also experienced coating failure and subsequent general surface corrosion.

2.2 MG – Interior roof and beam overlaps with crevice corrosion
