CITY OF DUVALL CITYWIDE FACILITIES ASSESSMENT AND MASTER PROGRAMMING REPORT

Prepared by ARC Architects in accordance with the
Agreement for Professional Services with the City of Duvall contract # 2021-26 as amended

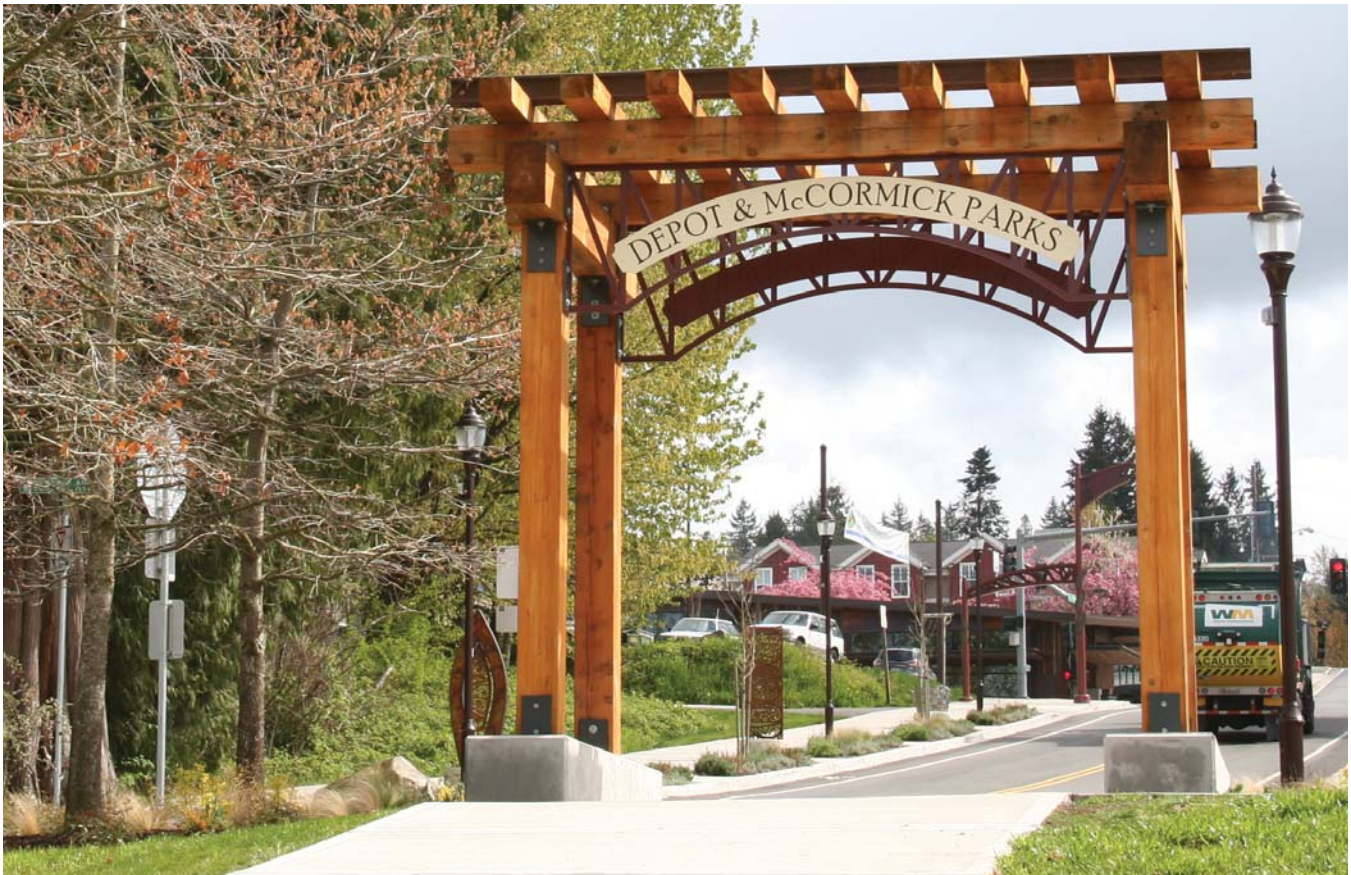
ARC recommends the City continue towards full design and construction improvements to meet their long-term needs prior to their current facilities becoming compromised to a point where public / staff safety and/or capacity levels are exceeded.

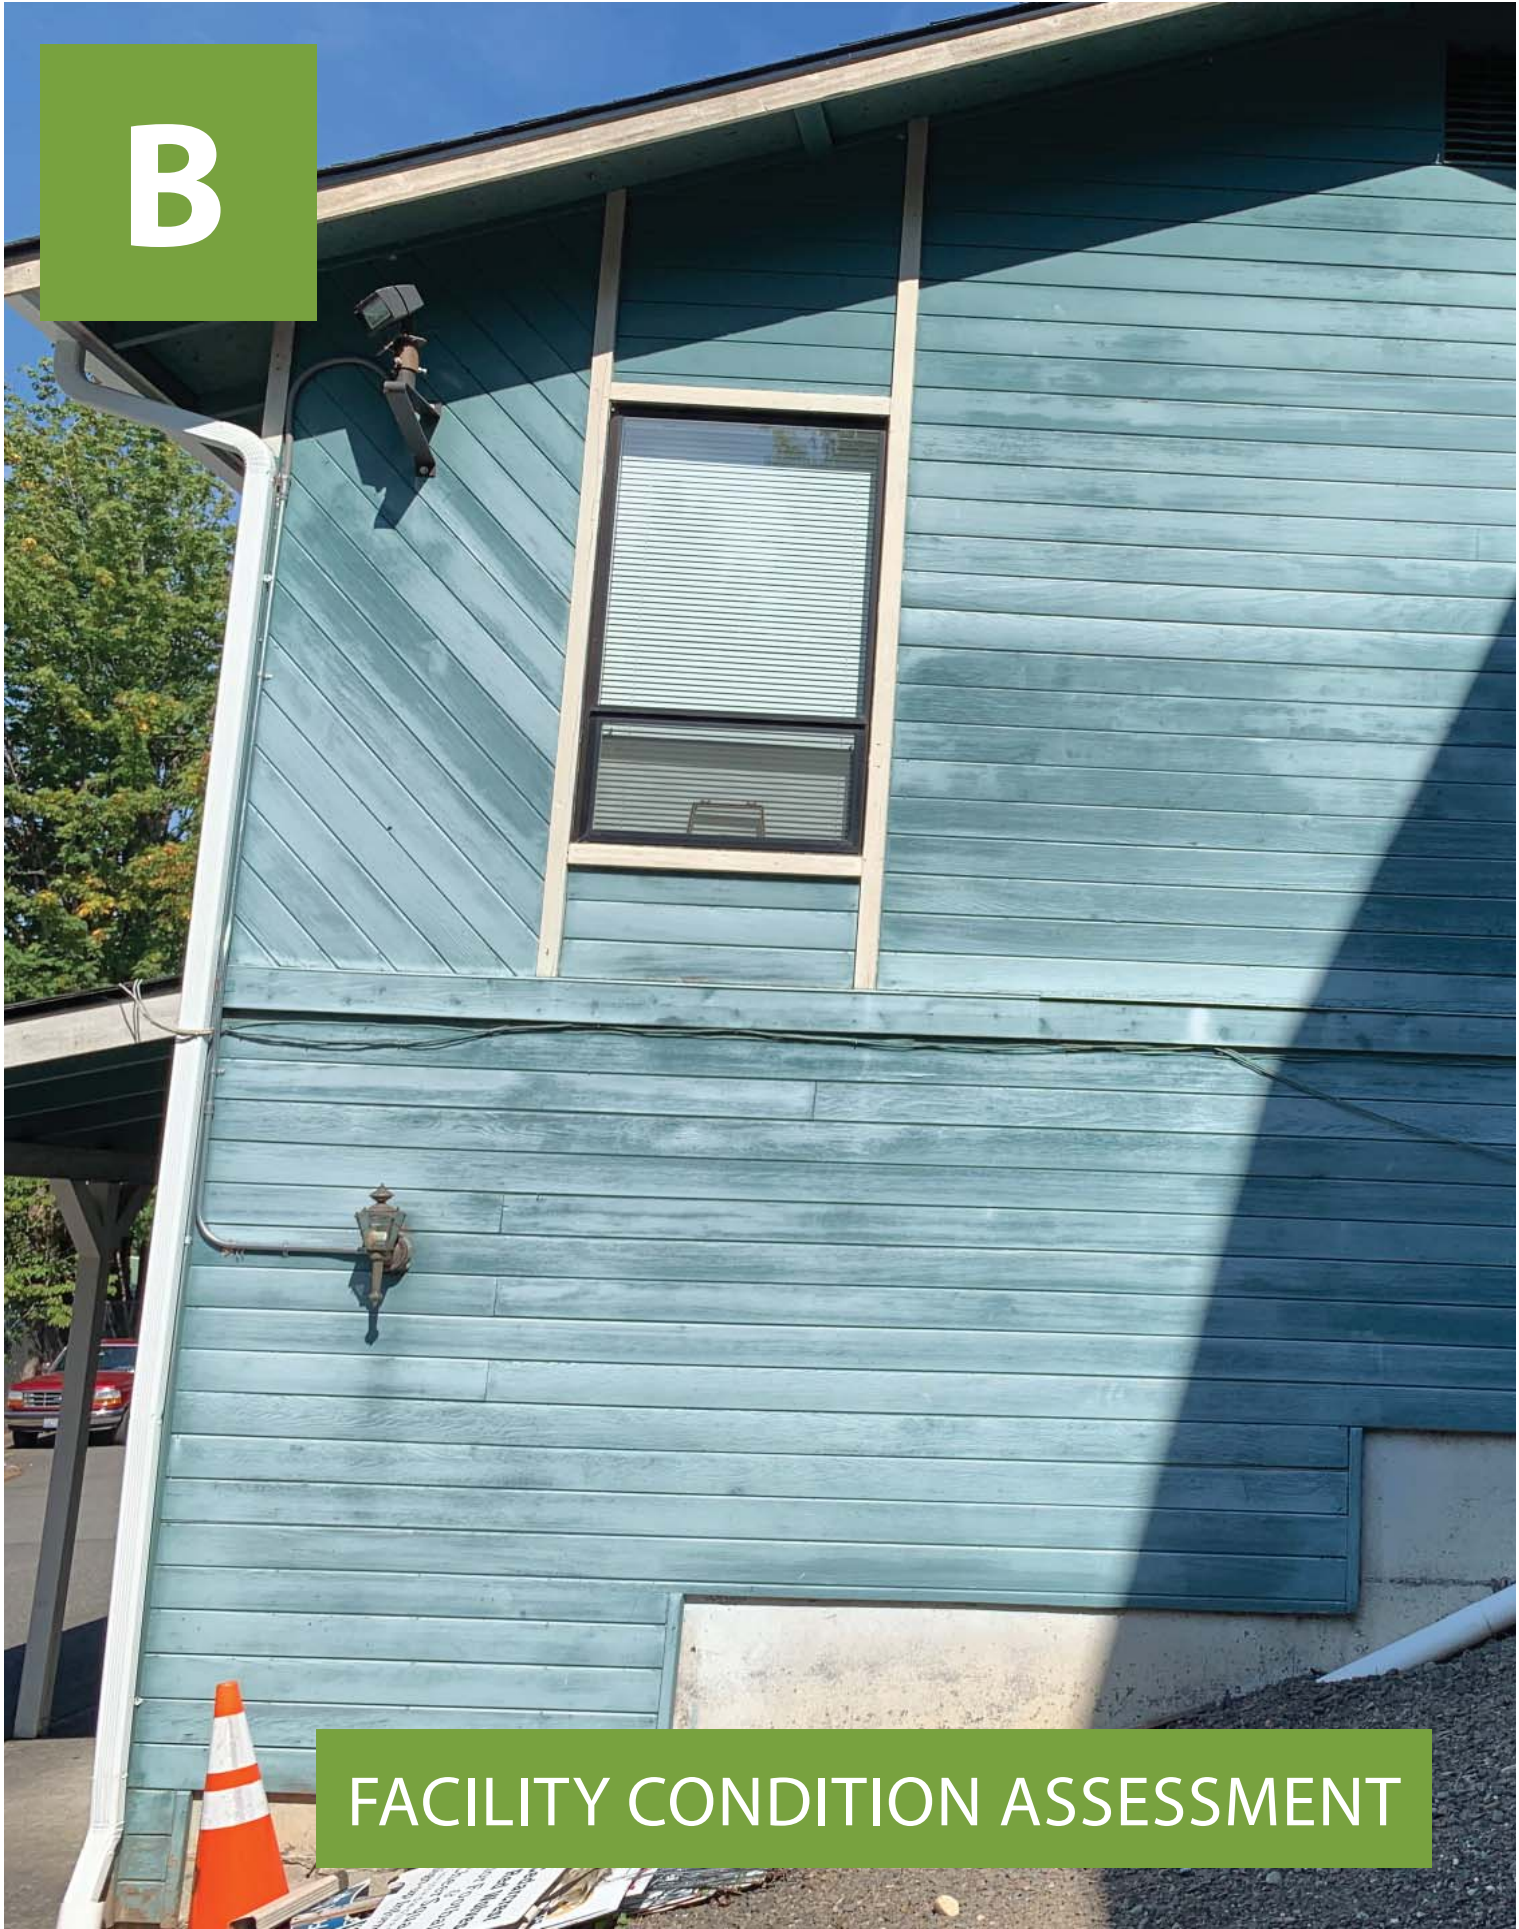
FACILITY CONDITION ASSESSMENT

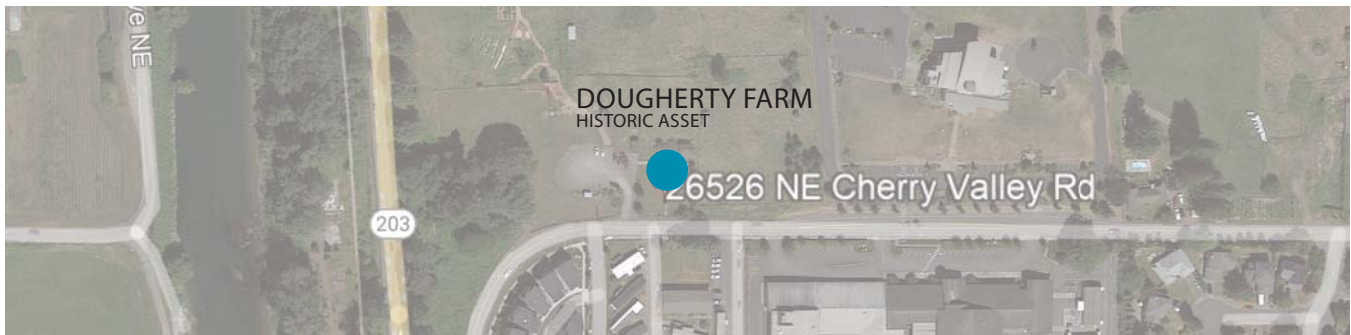
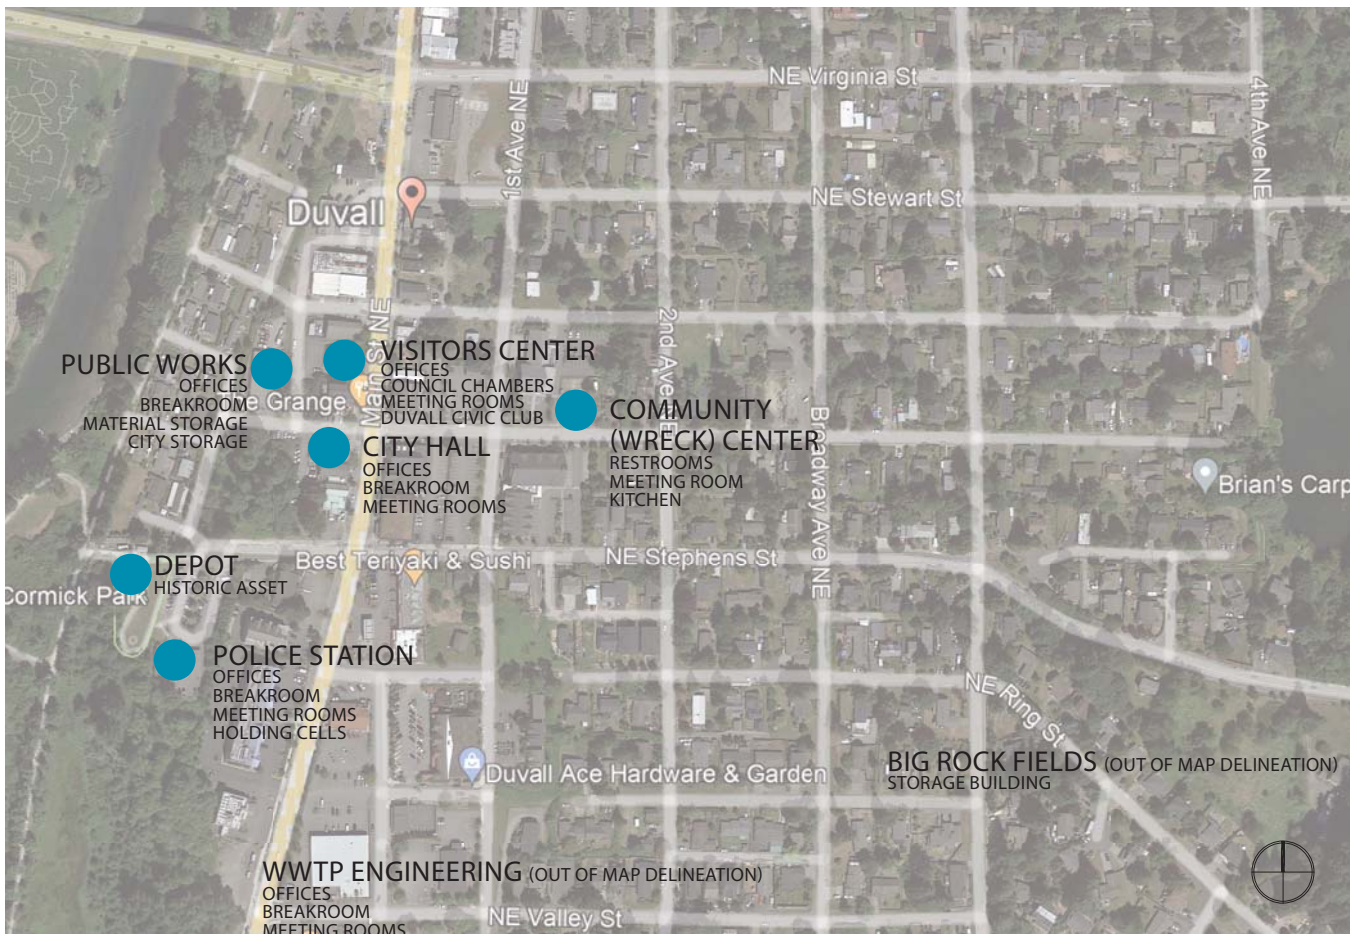
Duvall Aerial Key Plan

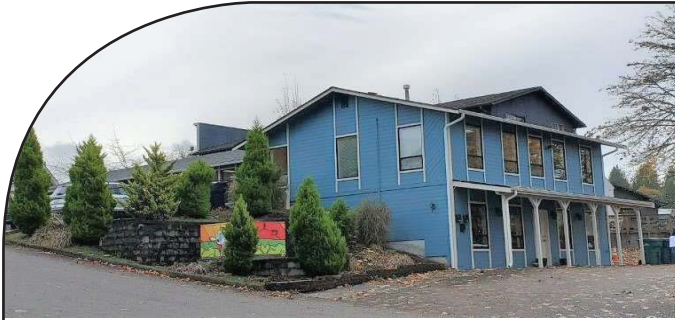
General Comments:
 Built - 1977; interior renovated in 2005-2006; Plated wood trusses in one story space and a two story addition at west. There is some vertical movement at the transition from one to two story condition. There is a rat infested crawlspace under the one story level. Conventional spread footings. Generally, well maintained; roofing appears newly replaced.

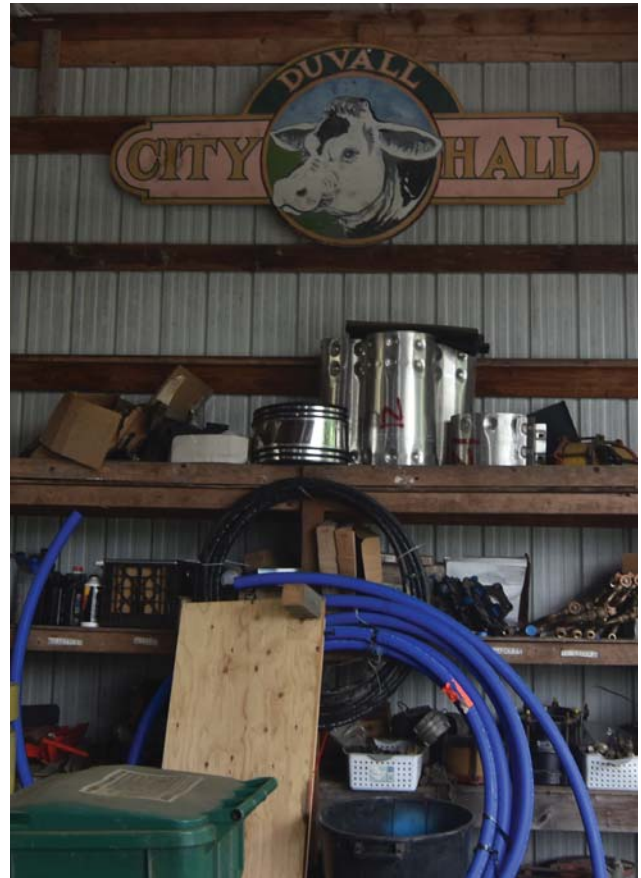
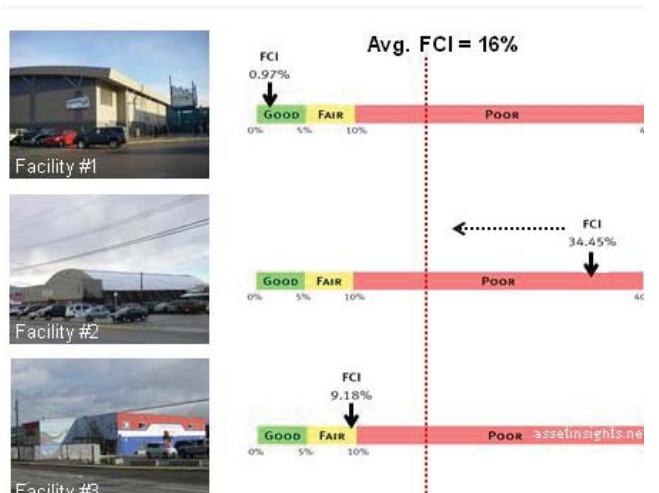
Table 1. Facility Condition Index Grade and Impact to Component Failure Risk, Residents and Staff

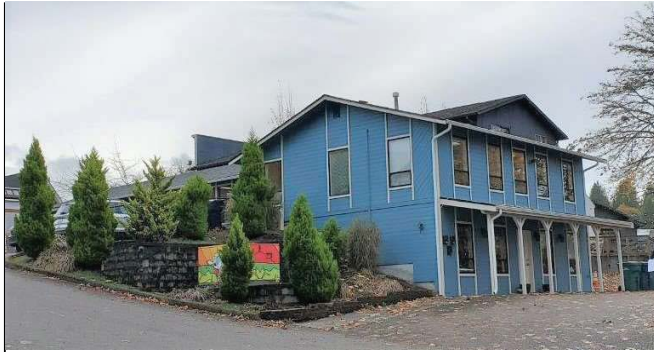
General Comments:
 Built - 1977; interior renovated in 2005-2006; Plated wood roof trusses in one story space and a two story addition at west. There is some vertical movement at the transition from one to two story condition There is a rat infested crawlspace under the one story level. Conventional spread footings. Generally, well maintained; roofing appears newly replaced.

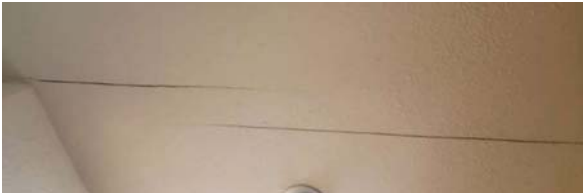
Transition cracks at the ceiling.

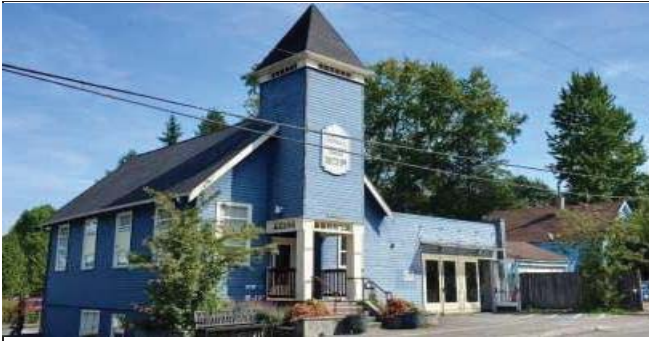
General Comments:
 The community center was originally constructed in 1938. The interior was remodeled in 1996 and there were major renovations completed in 2002. There were no drawings available for this building or any of the renovation work. Cracking observed at several west side foundation locations and basement beams/stud wall bearing plates exposed to weather. Age of structure likely negates lateral force resisting system. Lack of structural info is concerning.

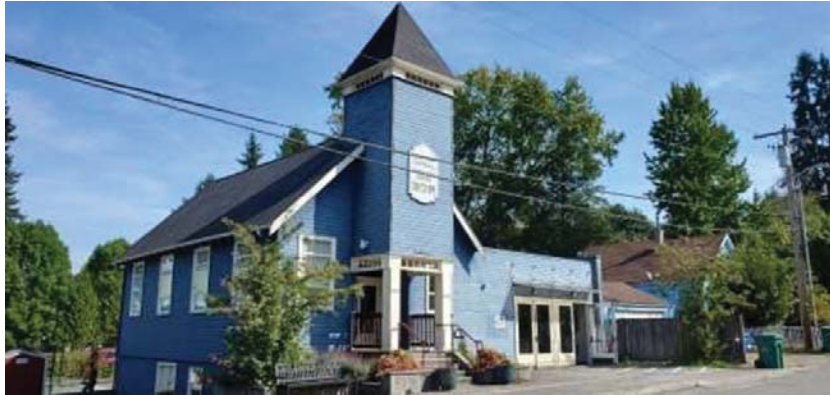
The building is a two-story gable roof structure with a tower attached to a one-story slab-on-grade structure with a low slope roof. The building measures approximately 54' x 50'. The space has a significant fly infestation problem, particularly at the bell tower. It is FSI's suspicion that the bell tower is leaking, and the degrading material in it is attracting the flies. The bell tower does not have any obvious vents. This is likely contributing to the flies getting stuck in the tower and then finding their way into the building through the adjoining wall.

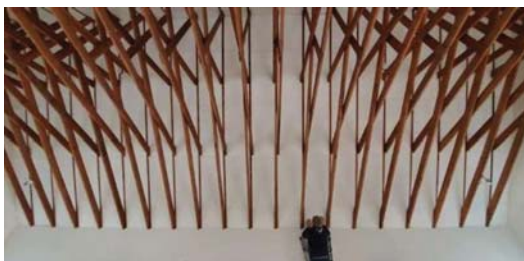
High bay roof trusses

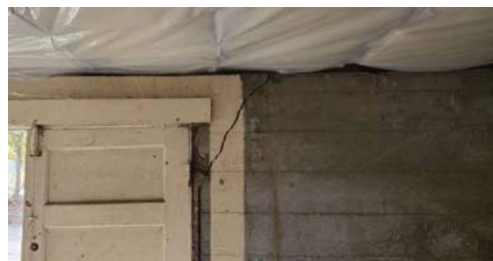
Cracks and signs of movement on the west wall

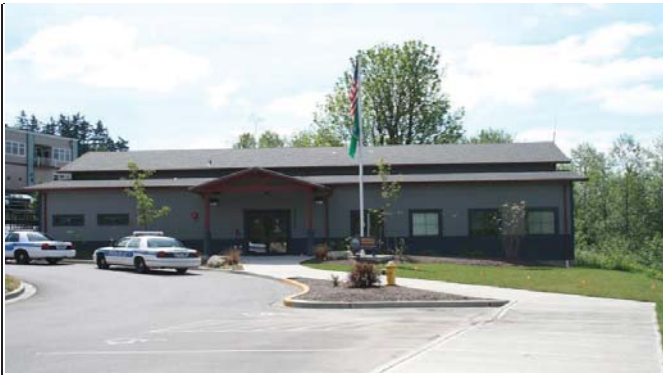
General Comments:
 Main Building: Original building constructed in 2004 no (original drawings); Notes indicate design per 1997 UBC; was intended to be a temporary structure (8-10 years); Modular wood construction (Williams Scotsman); Indications that building has experienced some settlement. Tenant indicates vertical movement in floor, doors jamming, etc. Sally port added in 2014 (80% progress drawings reviewed); designed to 2012 IBC; No indication of structural engineer on sally port drawings; all structural information shown on architectural drawings; No geotechnical report; 2000 psf allowable soil bearing assumed

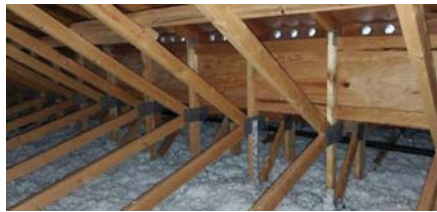
Police Station Roof Structure

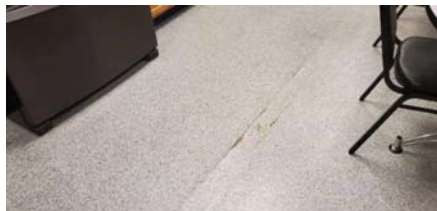
Cracks at the break room

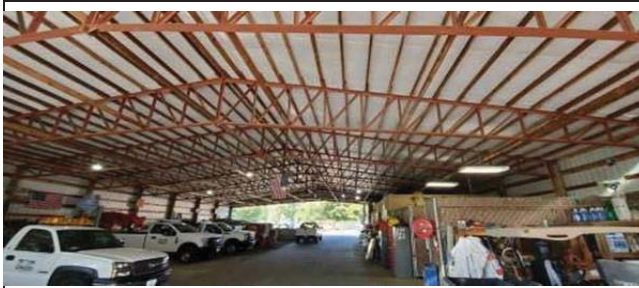
General Comments: This 9,000 square foot covered structure was constructed in 1997 after the collapse of the original barn structure. A 1,200 square foot office/locker facility was subsequently constructed within the footprint of the structure in the northeast corner. No drawings exist for either the covered structure or office/locker facility. Total economic life of 30 years. Structure has a remaining economic life of approximately 5 years. Pole buildings are often intended as unoccupied storage buildings, so the assumptions employed in its design are unknown. An unoccupied structure would have likely been designed for lower forces. For these reasons it is our recommendation that this building either be substantially upgraded to provide a complete lateral system or be replaced.

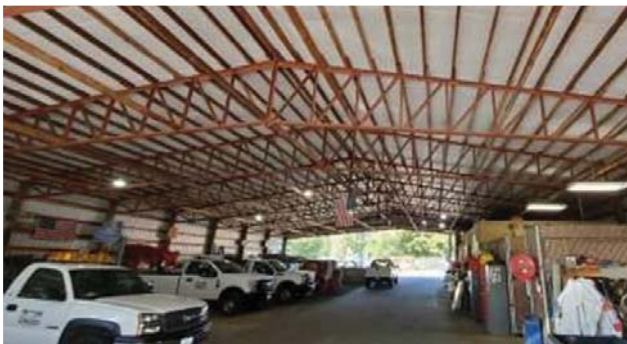
Left: Roof trusses at the maintenance yard with separate office structure below.

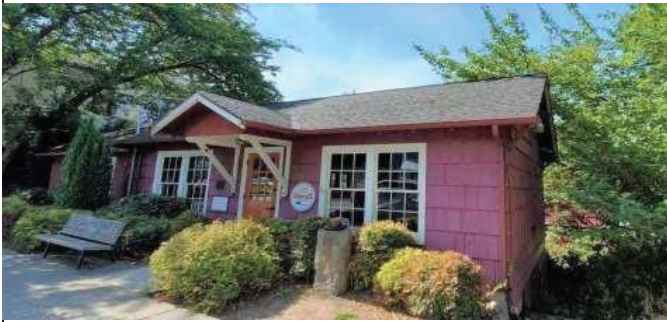
General Comments:
 The visitors center was constructed in 1935 with a 320 square foot wing added at the south face in 1959 and a large two story 2720 square foot addition to the west in 1988. No drawings existing for the 1935 or 1959 construction but a complete set of drawings for the 1988 expansion was provided for our review. This building was used primarily as a library until KCLS completed construction of a new library in 2004.

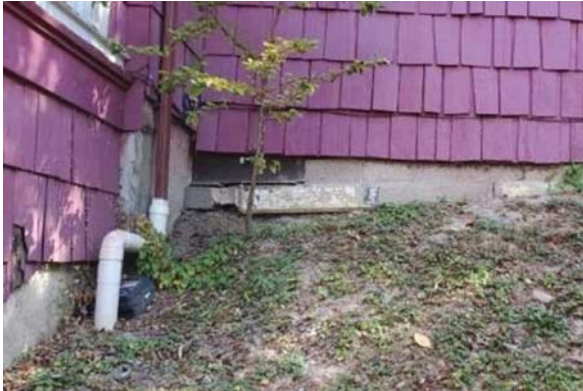
West foundation wall at the south wing

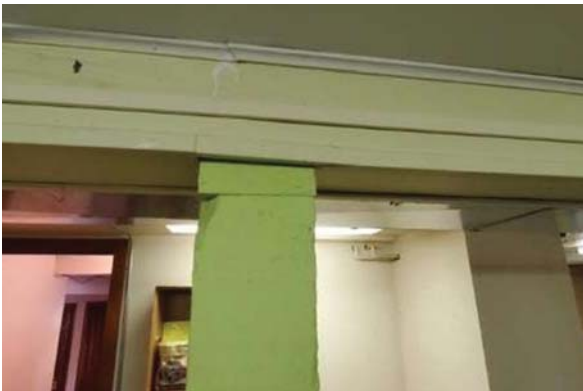
Lower level post is not anchored to the beam.

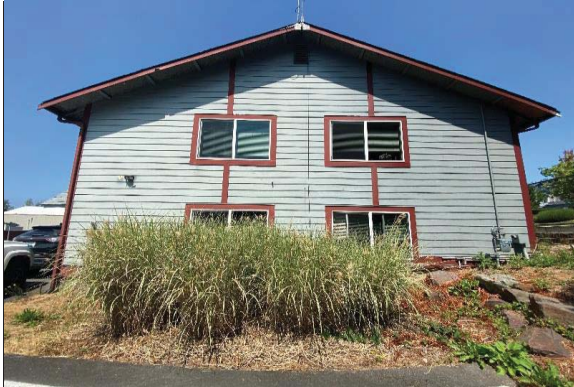
WWTP ENGINEERING BUILDING (PARCEL 132606-9132)

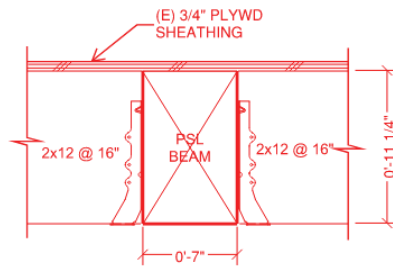
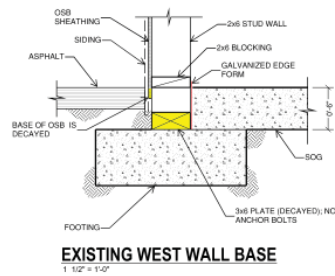
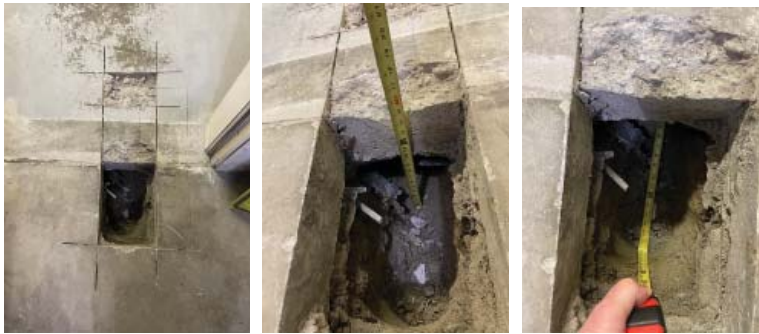
Additional potholing was requested along the two-floor section of the west exterior wall. The City decided not to proceed with the additional demolition at this time.

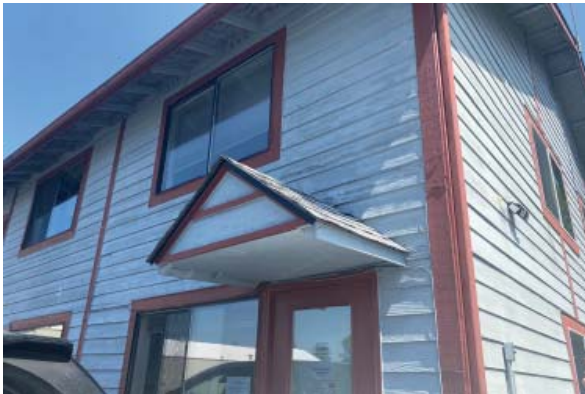
The main entrance with a cantilevered roof. The construction and attachment of the roof is unknown and shows indications that it may be failing. This is a hazard and should be removed and/or replaced.

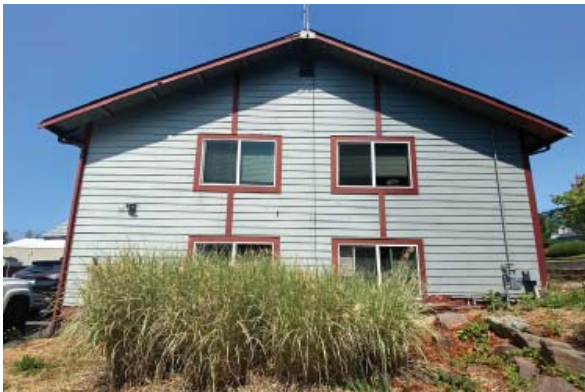
The south elevation is clad with fiber cement siding.

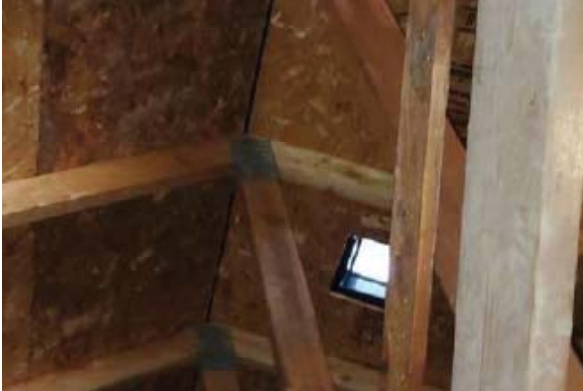
The roof structure consists of pre-manufactured plated wood trusses and are in good condition.

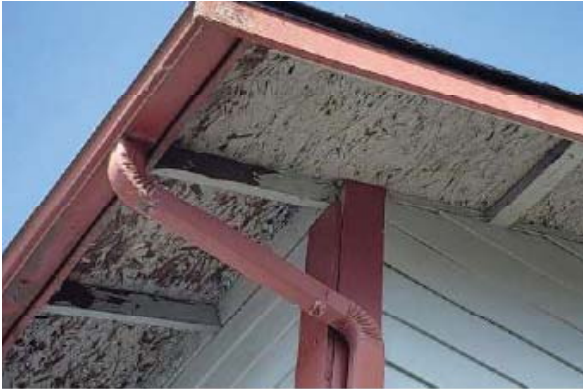
Paint is peeling and the OSB roof sheathing is exposed. Prolonged exposure can cause the sheathing to swell and deteriorate.

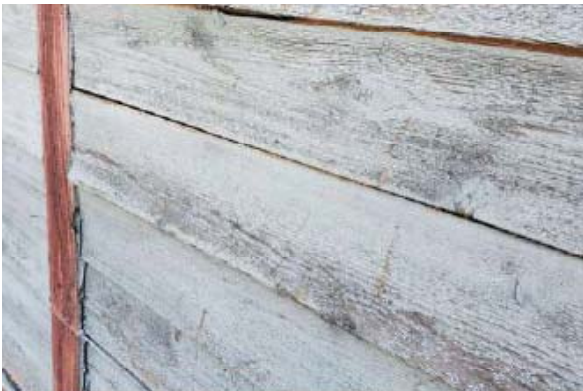
Detached siding at the east elevation

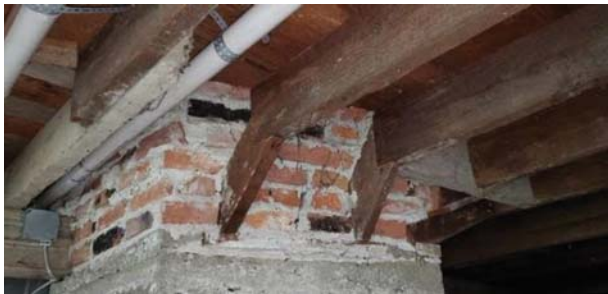
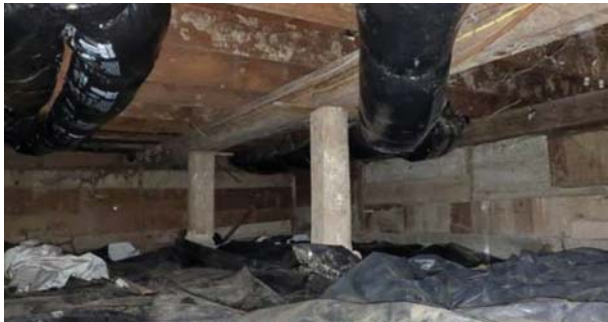
Top: Farmhouse floor framing around chimney and damaged joists.
Bottom: Farmhouse crawlspace posts without anchorage.

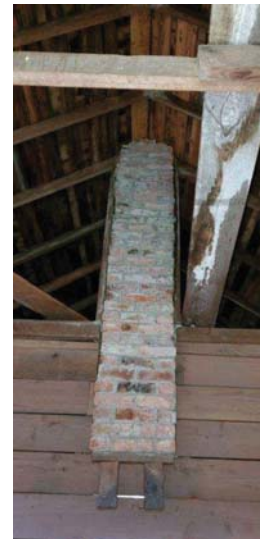
Bunkhouse - Unbraced chimney remnant.

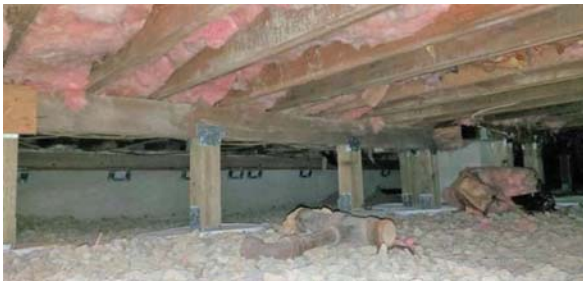
Crawl space anchorage.

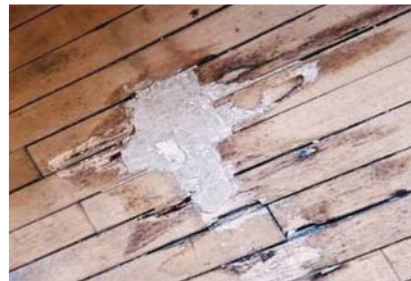
Existing flooring grout repair.

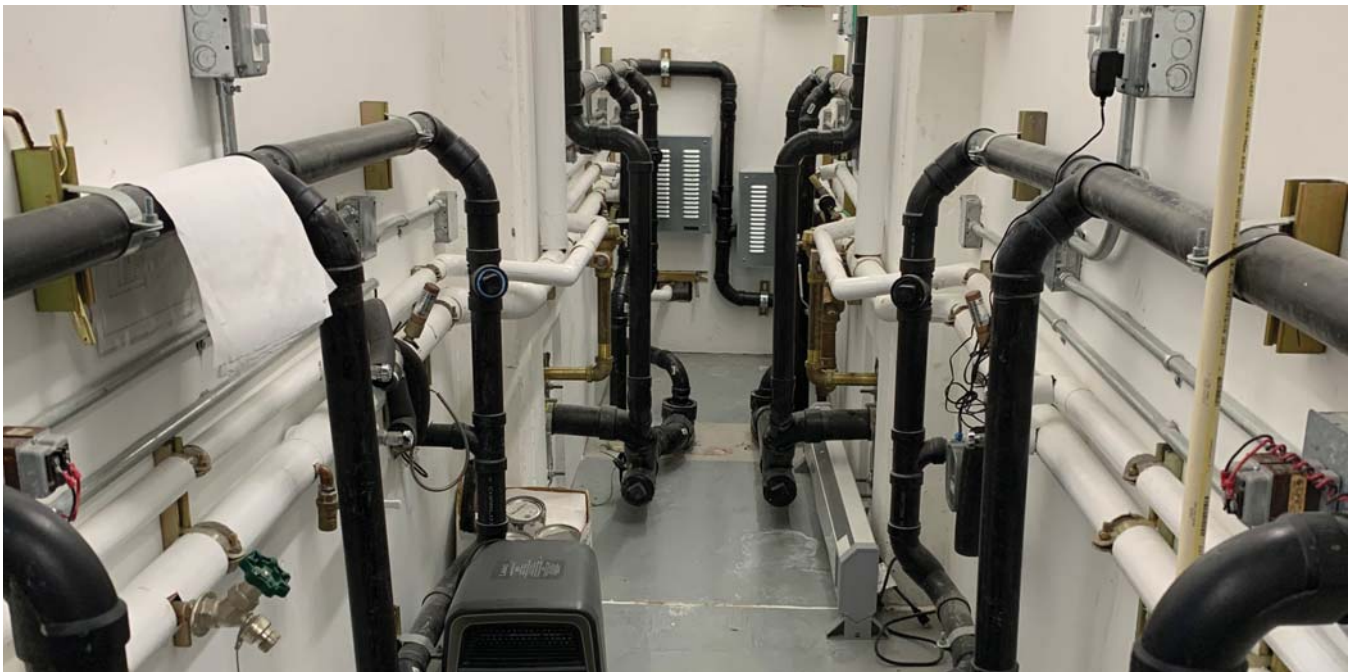
We recommend policy plan to be put into place in order to advance the city’s knowledge of asset maintenance.

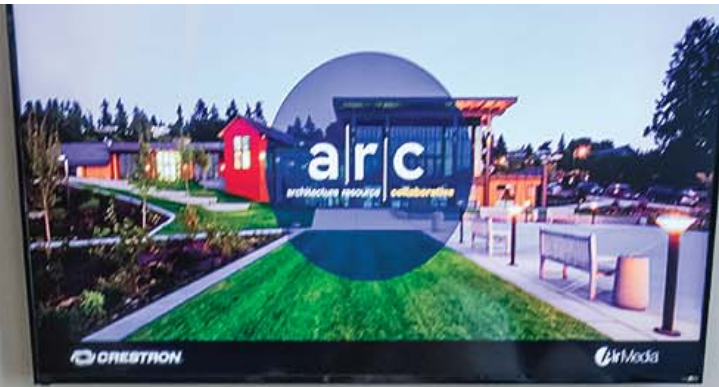
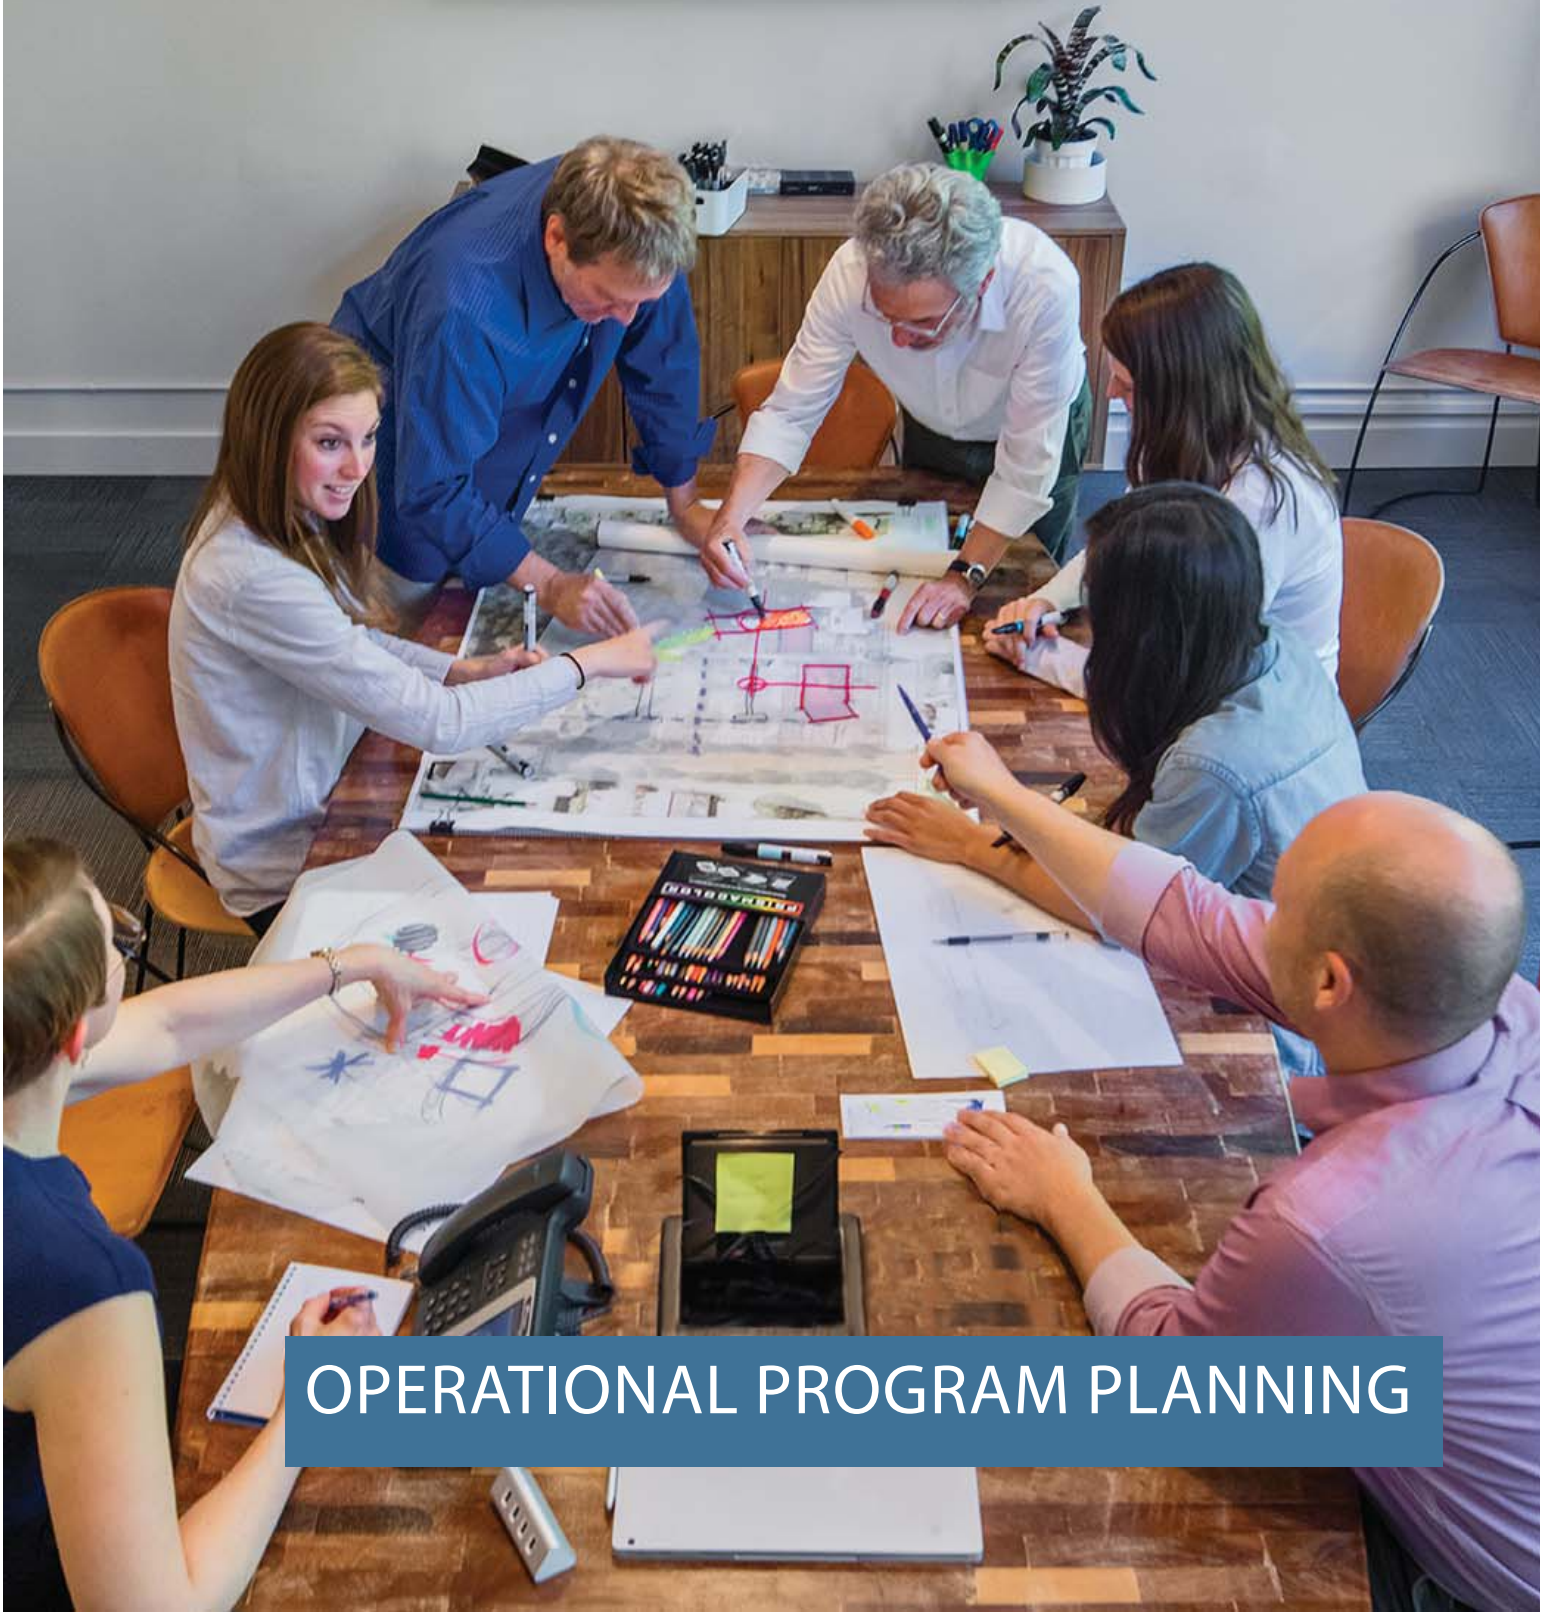
OPERATIONAL PROGRAM PLANNING

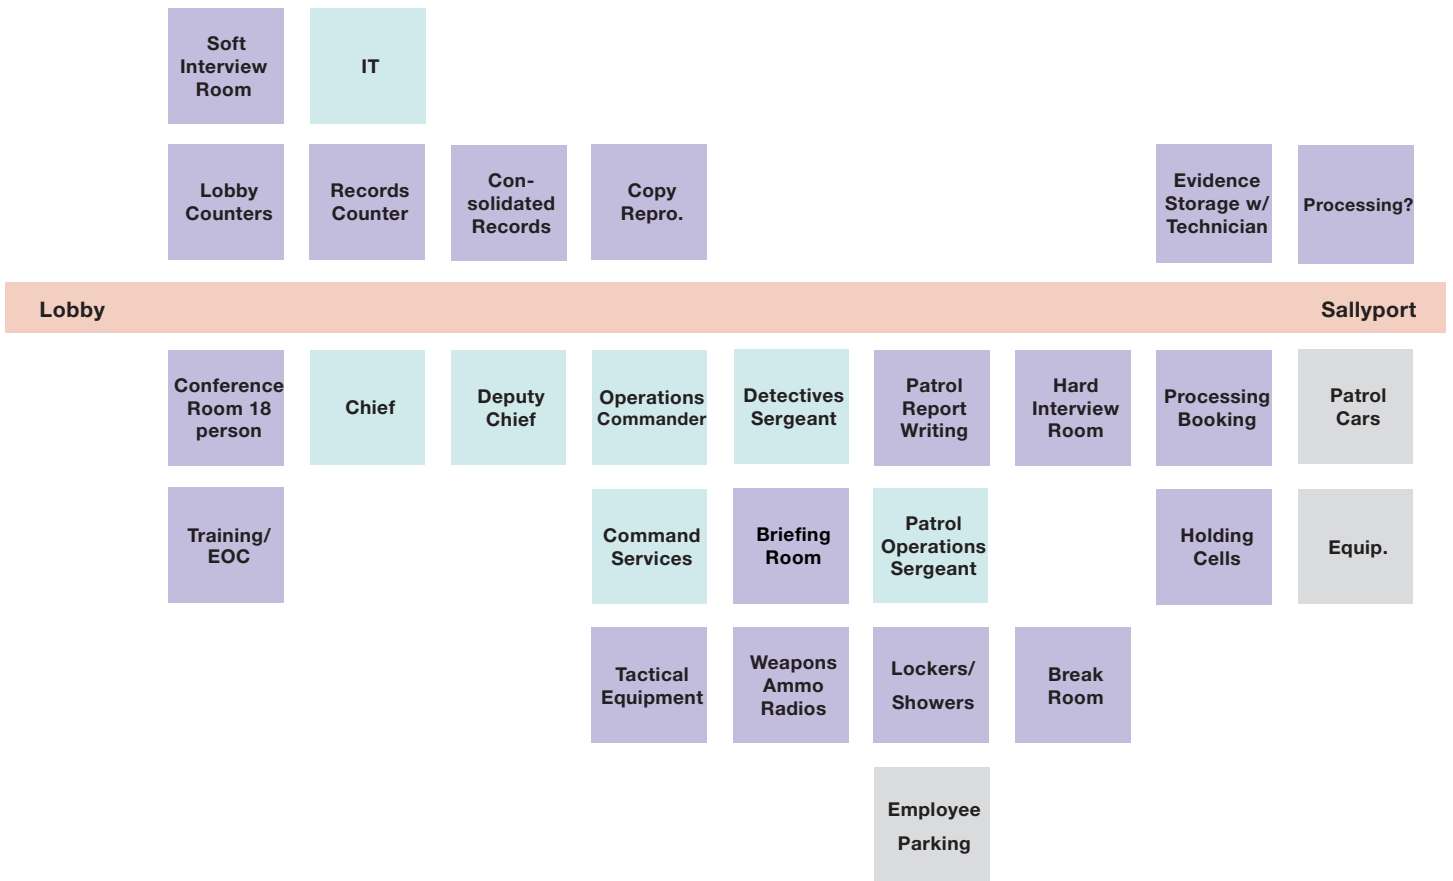
Duvall Police Adjacency Diagram

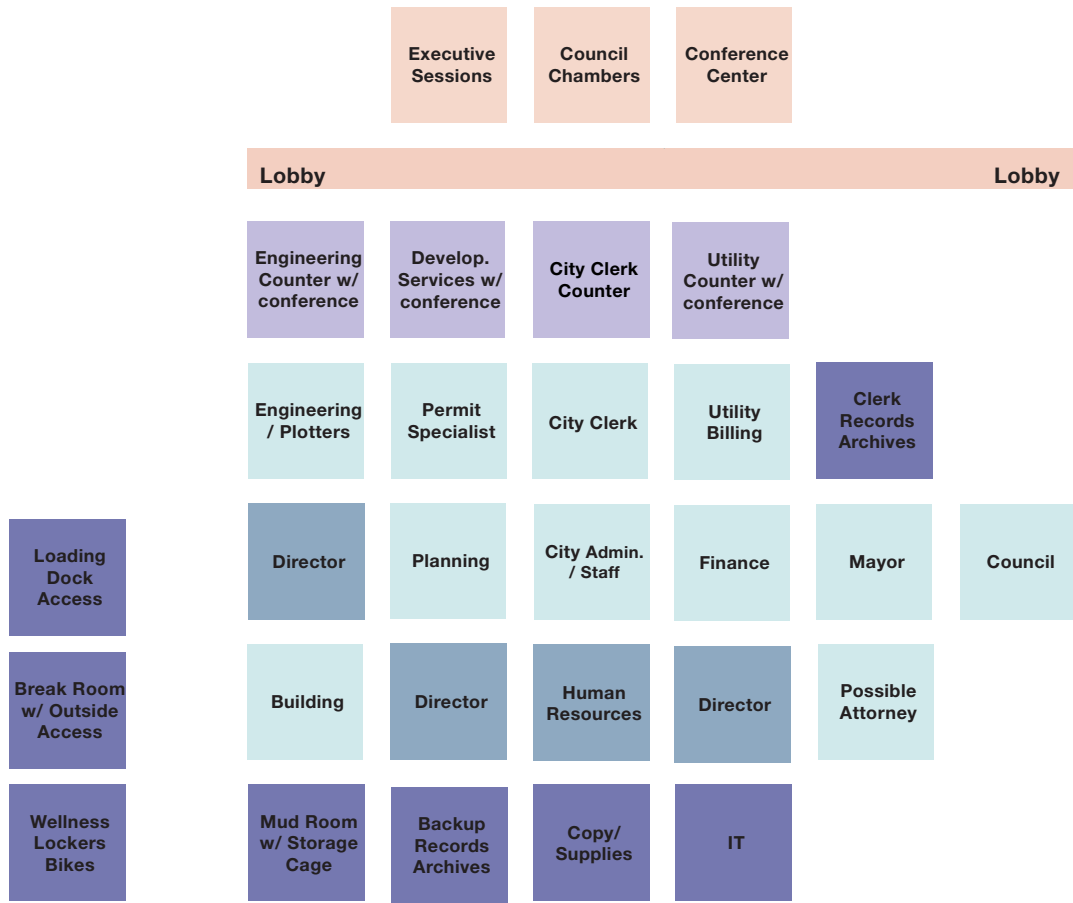
Construction Cost (\$)	Soft Cost (\$) (40%)	Project Cost (\$)
<u>NEW CITY HALL AND POLICE AT EXISTING VISITOR CENTER AND PUBLIC WORKS YARD - OPTION A</u>			
SITWORK	1,066,587	426,635	1,493,221
PUBLIC WORKS YARD RELOCATION	4,489,638	1,795,855	6,285,493
VISITOR CENTER UPGRADES	751,871	300,749	1,052,620
PARKING	4,935,552	1,974,221	6,909,773
CITY HALL	8,619,370	3,447,748	12,067,118
POLICE	5,325,520	2,130,208	7,455,728
TOTAL COST	25,188,538	10,075,415	36,474,466
